Repairability of Four CAD-CAM Materials

Abstract

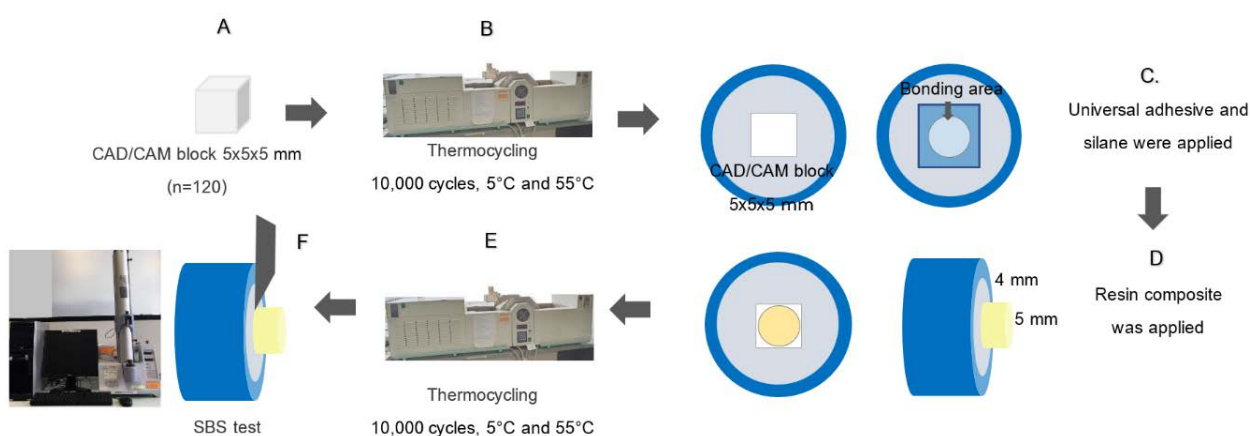
Figure 1 A. CAD-CAM blocks were sectioned into dimension of 5x5x5 mm to produce 120 specimens
B. Thermocycling was performed on all specimens
C. Bonding areas received a drop of adhesive (universal adhesives/silane coupling agent)
D. Following bonding procedure, resin composite was applied onto prepared specimens in 2 mm thick increments to fill up the mold
E. Prior to SBS testing, thermocycling was performed on all specimens
F. Subsequently, the SBS test was performed

For specimen preparation, 120 specimens, each measuring 5x5x5 mm, were obtained by sectioning the original CAD-CAM blocks (initial dimensions: 12x14x18 mm) using a low-speed diamond saw (Isomet 1000, Buehler, Lake Bluff, IL, USA) (Fig. 1A). Then they underwent a thermocycling (KMILT, Bangkok, Thailand) protocol for

10,000 cycles using temperatures between 5°C and 55°C, with a dwell time of 30 seconds to simulate one year of oral service (Fig. 1B)¹⁷ The specimens were mounted in self-curing acrylic resin. This was followed by a 30-second polishing step using 320-grit silicon carbide abrasive papers under water irrigation. To ensure cleanliness, the specimens were then immersed in distilled water for ultrasonic cleaning for ten minutes. Table 2 details the chemical composition of the materials tested.

To simulate aging effects, all ceramic specimens underwent 10,000 thermocycles 5°C and 55°C with a 30

seconds dwell time (Fig. 1E). Subsequently, shear bond strength (SBS) was measured using a universal testing machine (EZ-S, Shimadzu, Japan). The SBS test involved applying a force at a constant speed of 0.5 mm/min using a knife-edge apparatus positioned between the CAD-CAM restorative material and the resin composite, with a separation distance of 1.0 mm (Fig. 1F). Shear stress on the specimens was progressively raised until they fractured. The force required to cause this failure was then documented (N). The SBS value was determined by dividing the highest SBS by the adhesive area (mm²). According to ISO29022:2013, a pre-test failure was recorded as 0 MPa. Any pretest failures, such as dislodgement of the composite button during removal of the button mold or excess composite, were noted accordingly.

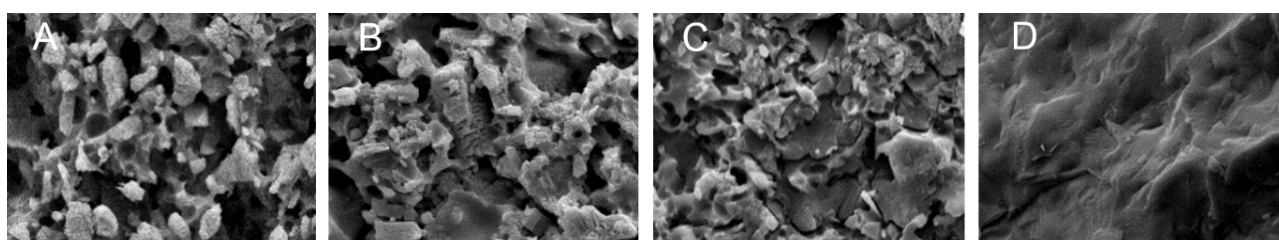
Figure 2 SEM of Vitablocs Mark II® (Original magnification x5000). 2A; After HF, the glassy phase partially dissolved. 2B; Adhesive failure in VM+MN. 2C; Mixed failure in VM+CUB. 2D; Cohesive failure within ceramic in VM+SUP

The SEM images (original magnification of 5000x) of CAD-CAM materials treated with various surface treatments, as shown in Figures 2-5, exhibited bonded surfaces after the SBS test to confirm mode of failure.

The study also revealed that VM + SUP had the highest incidence of cohesive failure, while VE + SUP showed the highest occurrence of mixed failure. This suggested that etching these ceramic types enhanced surface irregularities, thereby improving shear bond strength. Specifically, specimens repaired with SUP exhibited more cohesive and mixed failures compared to those repaired with CUB and MN. These results were consistent with the average bond strength findings, which showed that VE + SUP and VM + SUP achieved the highest bond strengths.

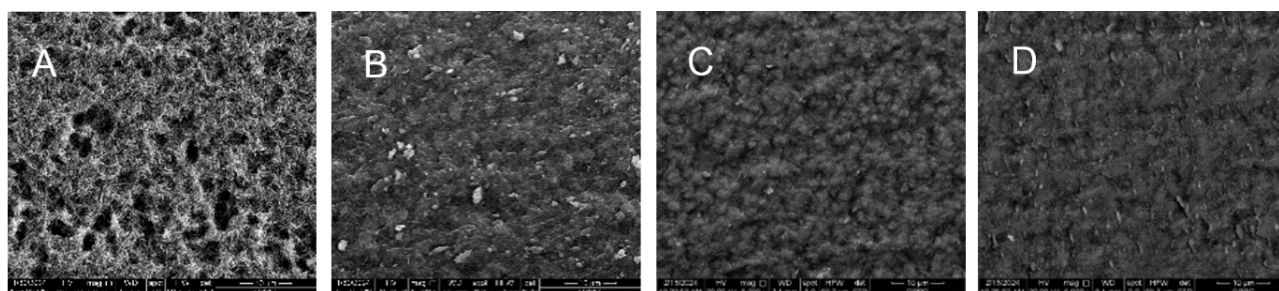
Figure 3 SEM of IPS e.max CAD® (Original magnification x5000). 3A; After HF, the glassy phase, partially dissolved phase, partially dissolved with predominantly crystalline phase. 3B; Adhesive failure in IE+MN. 3C; Adhesive failure in IE+CUB. 3D; Adhesive failure in IE+SUP

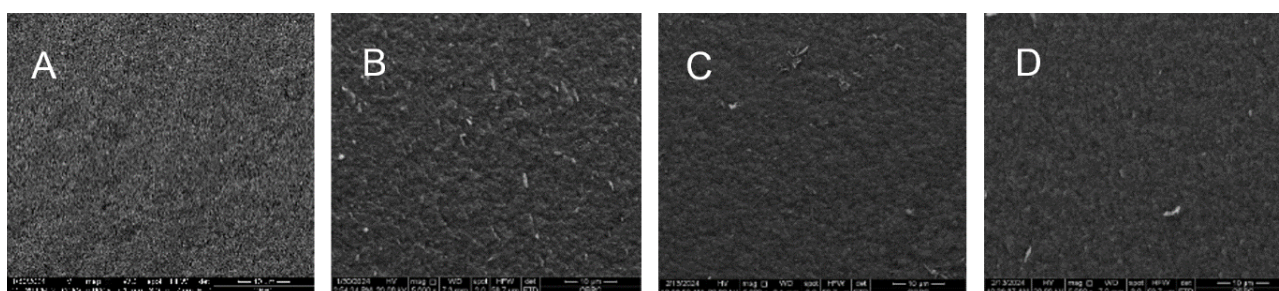
Figure 4 SEM of Vita Suprinity® (Original magnification x5000). 4A; After HF, the glassy phase partially dissolved with predominantly crystalline phase. 4B; Adhesive failure in VS+MN. 4C; Adhesive failure in VS+CUB. 4D; Adhesive failure in VS+SUP

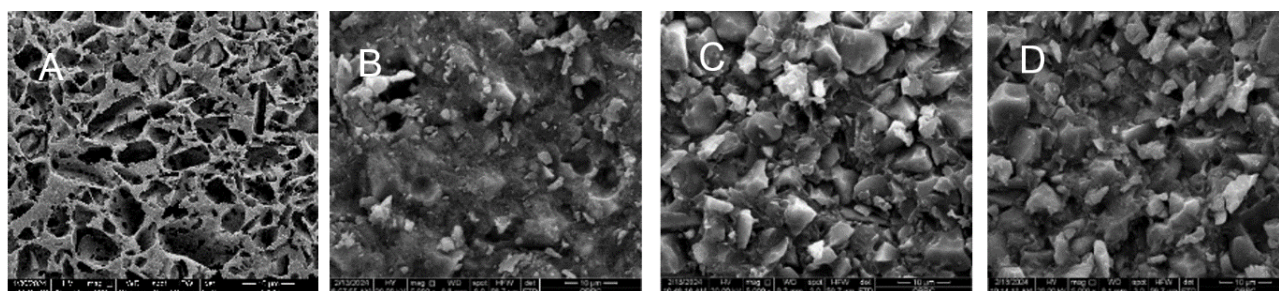
Figure 5 SEM of Vita Enamic® (Original magnification x5000). 5A; After HF, the glassy phase partially dissolved. 5B; Mixed failure in VE+MN. 5C; Mixed failure in VE+CUB. 5D; Mixed failure in VE+SUP
