## Efficacy of Restorative Primers on the Shear Bond Strength of Polymer-infiltrated Ceramic Network to Resin Cement

This study investigated the shear bond strength (SBS) of polymer-infiltrated ceramic network (PICN) to resin cement by application of different restorative primers which are commonly available in dental clinic. Fifty square-shaped PICN specimens were prepared and treated with 5% hydrofluoric acid. Then, the specimens were randomly divided into five groups with different surface treatments as follows: non-chemical surface treatment as control group (C), surface treatment with Monobond N (MN), Alloy Primer (AP), Super-Bond Universal Ceramic Primer (SB), and Clearfil™ Ceramic Primer Plus (CF). The specimens were then bonded to cylindrical resin composite block with Panavia™ V5. The SBS test was performed with universal testing machine. Data were recorded and statistically analyzed by One-way ANOVA and Tamhane's T2. The mode of failure was also evaluated under a stereomicroscope at 35x. The results showed that the mean SBS values of MN, CF, and SB groups were significantly higher than that of the C group ( $p < 0.05$ ), but not significantly different to each other ( $p

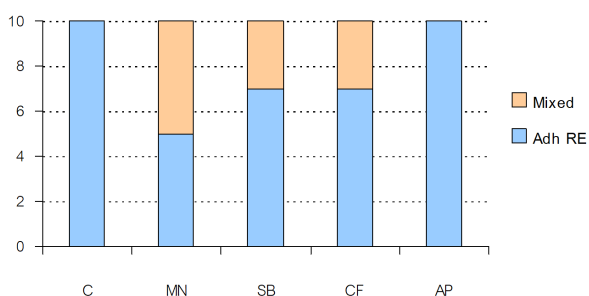
**Figure 1** The mode of failures of each group

The mode of failure (Figure 1) showed that the C and AP groups exhibited only adhesive failure between the resin cement and VITA Enamic® (Adh RE) in all specimens. The others showed Adh RE combined with mixed failure (Adh RE with Co E). The MN group showed the most mixed failure followed by the CF and SB groups.

The mode of failure investigation in this study showed all adhesive failure between resin cement and PICN (Adh RE) in the C and AP groups. This could imply that the bond is the weakest point of the bonded interface,<sup>18</sup> while the MN, CF, and SB groups showed Adh RE and mixed failure (Adh RE with Co E). This result is in agreement with the SBS value which revealed that the C, and AP groups showed significantly lower SBS values than those of the MN, CF, and SB groups. Thus, it might be concluded that the bond strength between resin cement and PICN is the weakest point and could be improved by applying the silane containing restorative primer which is in accordance with the mean SBS value observed in the study.
